DEPARTMENT OF TRANSPORTATION**DIVISION OF ENGINEERING SERVICES**

Office of Structural Materials

Contract #: 04-0120F4Cty: SF/ALA Rte: 80 PM: 13.2/13.9File #: 69.15**SOURCE INSPECTION REPORT****Resident Engineer:** Pursell, Gary**Address:** 333 Burma Road**City:** Oakland, CA 94607**Report No:** SIR-002608**Date Inspected:** 13-Aug-2010**Project Name:** SAS Superstructure**OSM Arrival Time:** 700**Prime Contractor:** American Bridge/Fluor Enterprises, a JV**OSM Departure Time:** 1900**Contractor:** Zhenhua Port Machinery Company, Ltd (ZPMC), Changxing Island **Location:** Shanghai, China**Quality Control Contact:** Mr. Don Walton**Quality Control Present:** Yes No**Material transfer:** Yes No N/A**Sampled Items:** Yes No N/A**Stock Transfer:** Yes No N/A**OK to Cut:** Yes No N/A**Rebar Test Witness:** Yes No N/A**Delayed/Cancelled:** Yes No N/A**Other:** Coating Inspection**Bridge No:** 34-0006**Component:** See Below**Bid Item:** 77, 78, 79**Lot No:** B #204**Summary of Items Observed:**

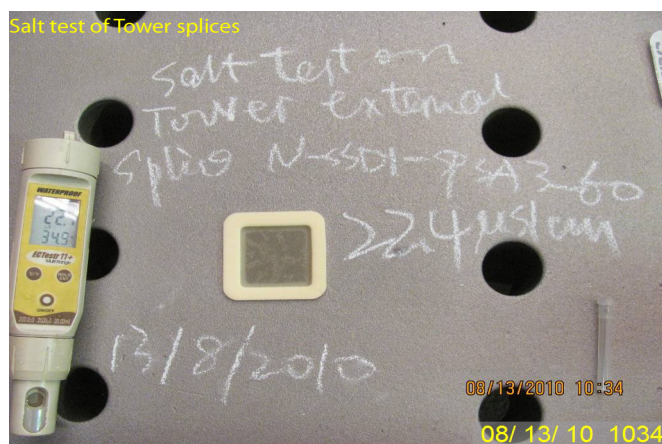
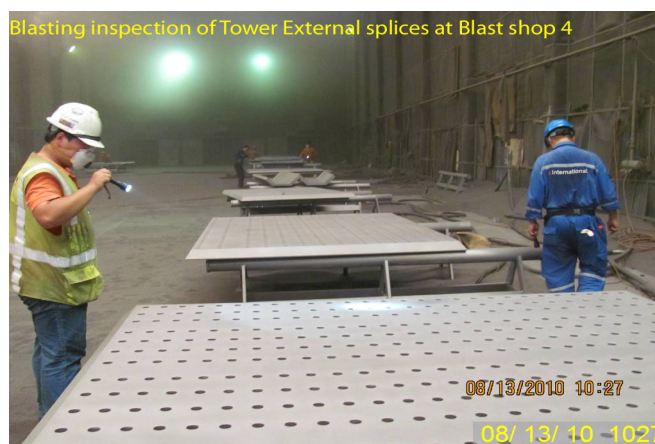
2. An inspection was requested on the Tower Splices- 83mtr. for surface preparation inspection, vide inspection request no. T 1027 at Blast shop no. 4. This QA inspector observed, ABF inspectors Mr. Shi Stone and Mr. Hong inspected all the splice surfaces. The surface profile measured by ZPMC inspectors at 3 places by Coarse grain method found to be 66 to 85 microns. The Results of residual chlorides test conducted by ZPMC inspectors found to be 22.4 us/cm. The result of Salt test and Surface profile found to be acceptable as per contract Documents. These splice plates found to be accepted by ABF Inspectors for Interzinc 22 application. International protective coatings technical service representative Mr. Li Peng. was found present during the course of this inspection process. (Photo of 83 mtr. splices and salt test result at Blast shop 4 is attached)
